RCRA FACILITY ASSESSMENT

FINAL REPORT

GRUMMAN AEROSPACE CORP.
NAVAL WEAPONS INDUSTRIAL RESERVE PLANT
CALVERTON, NEW YORK

SEPTEMBER 30, 1992

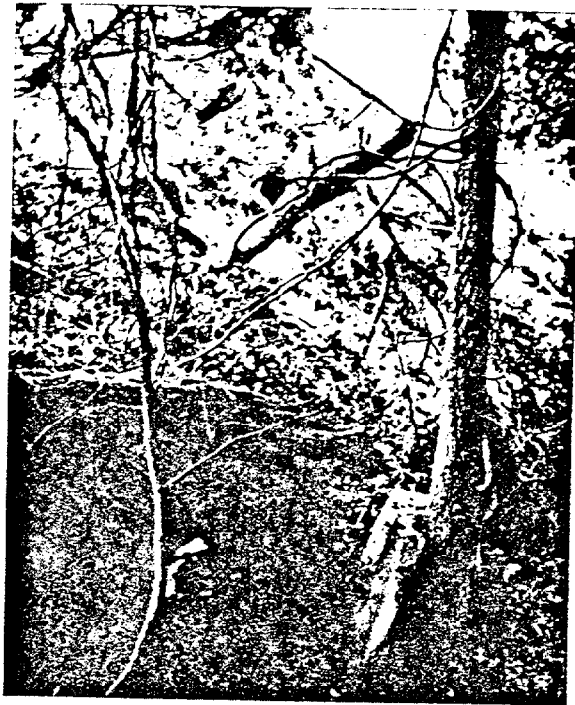
Hazardous waste or hazardous waste constituents are not known. However based on facility's past activities and discovery of paint pails with residues and 55 gallon drums in and around the pond in the past and during the VSI, there is a possibility of these drums and pails having contained petroleum based products and products with high heavy metal content, when disposed. This might have resulted in leaching of hazardous constituents into the ground water, which discharges into the Swan pond and finally into the Peconic river.

3. N-E pond area showing partially buried 55-gallon drum.

A sampling visit is recommended to take soil samples around the site. Also ground water samples should be taken after installing cluster wells.

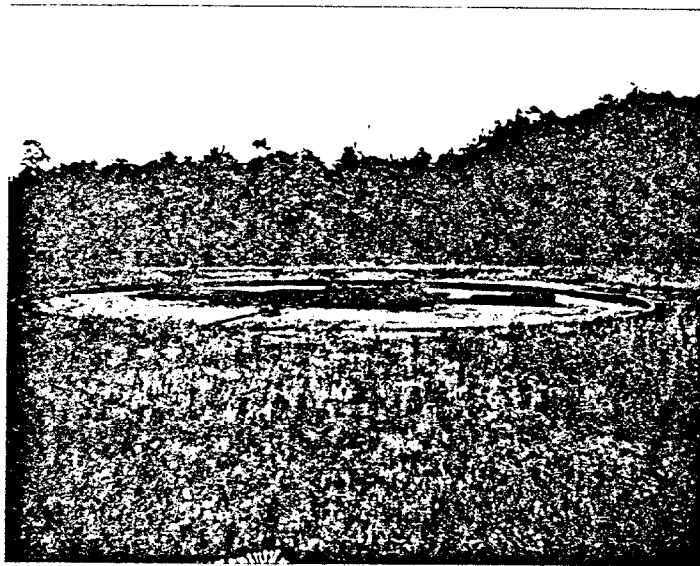
burning oil in a controlled fashion in a concrete pit with secondary containment, instead of an earthen pit. During the VSI the signs of potential release were evident as heavily stained soil all around the training area was observed. A number of monitoring wells and a recovery well were seen installed around the site. No unusual affects on the vegetation could be seen during the VSI.

4. Fire Rescue training area with new concrete pad.

RFI recommended. Soil, subsoil samples in the area and ground water samples from upper glacial aquifer at different depths, are recommended. Since recovery well is already installed to prevent the migration of contamination, another one is not recommended at this time.

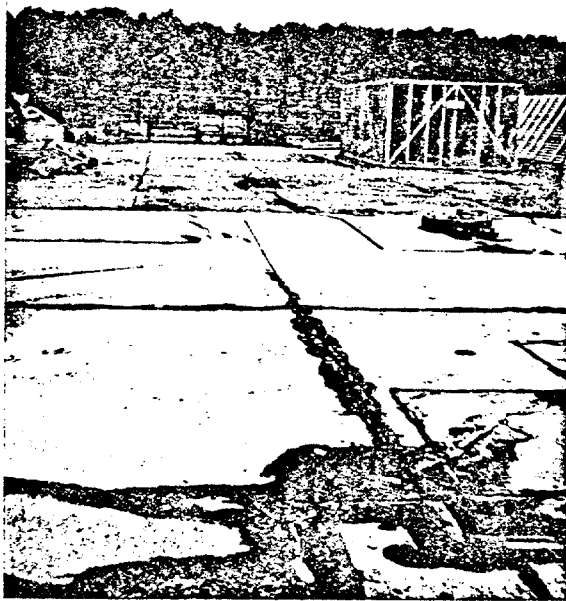
6. Old Fuel Calibration/ Engine run up area (4B)

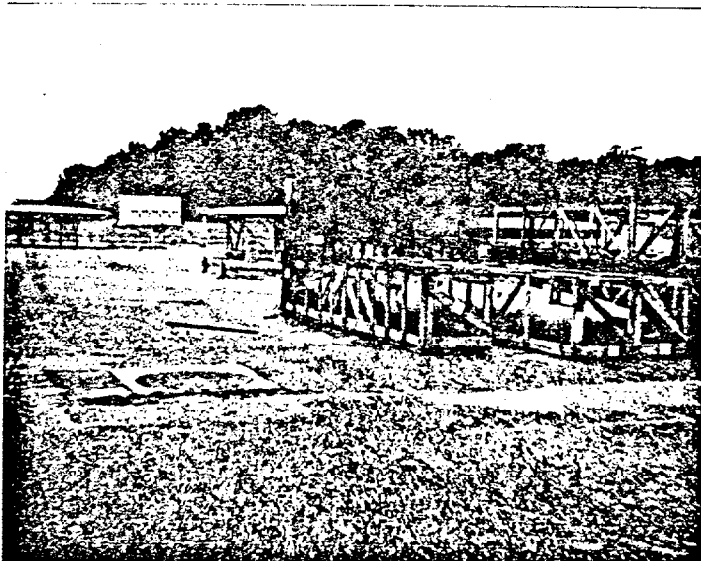
The facility was in operation until 1988, and was being used for waste like methyl ethyle ketone, paints, phenolics and 1,1,1 trichloromethane. Most of the material stored is as defined hazardous under Part 371. The site is now paved and is being used for storage of empty jet fuel tanks. No sign of any release could be seen during VSI.

7. Old Drum Storage Area.

The unit has been closed officially under RCRA. No action is recommended.

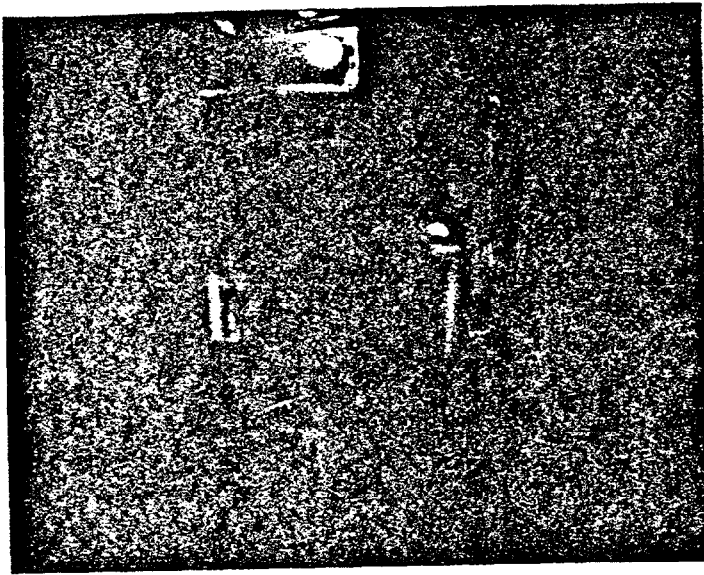
Waste treated at the plant is waste water from the paint and paint stripping operations, and the waste water is contaminated with chromium and phenolic materials. The resultant discharge into the surface water meets the discharge levels as provided by SPDES permit and the resultant sludge is transported to the Grumman, Bethpage facility for vacuum filtration. No problem area's could be discovered during the VSI.

8. Industrial Waste Water Facility.

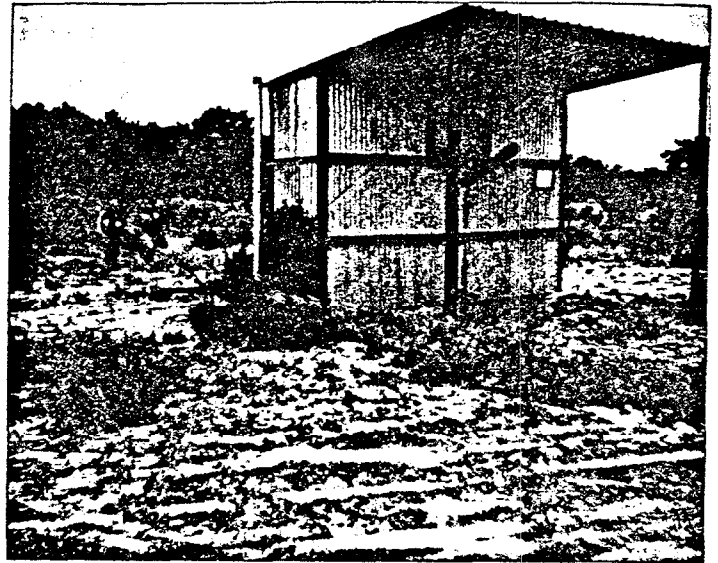
The area is located to the northwest of the activity's runways and industrial areas. It was a site for controlled demolition of excess or off specification ammunition from 1957 to 1985. Personnel destroyed the ammunition by setting fire to 5 to 10 gallons of various types of waste fuel in a 55 gallon drum in an unlined pit. The ammunition was released in a controlled fashion into the fire and burned. About 1700 rounds of ammunition is believed to be destroyed every year. The waste ammunition is still being disposed in the area, but now a concrete pit with double cover on the top, right next to the old site, is being used. No sign of any release or distressed vegetation could be discovered on the site.

10. Ammunition demolition area.

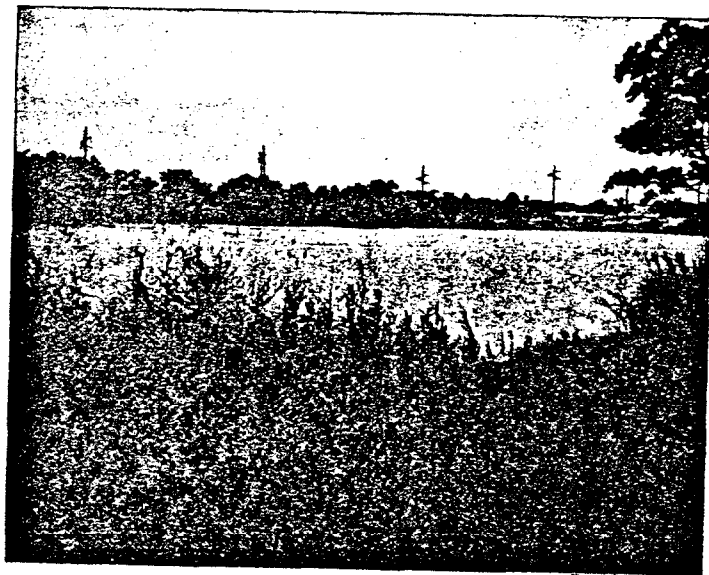
11. McKay lake

A Sampling visit for surface water and sediments is recommended.
